Enfield Drainage and Erosion Work Group

IDENTIFIED DRAINAGE AND
EROSION ISSUES

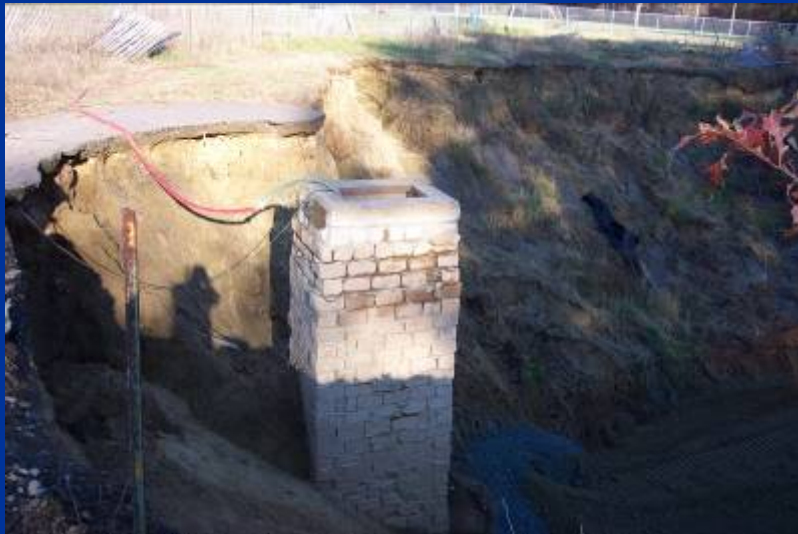
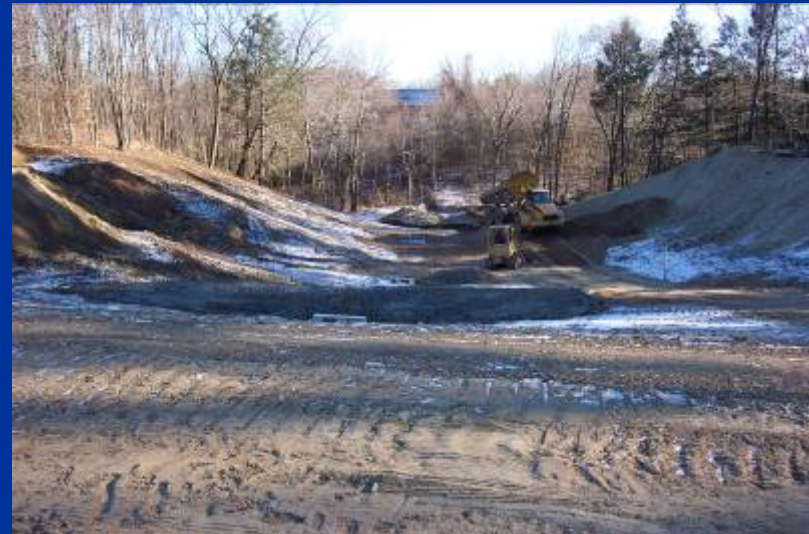
- JFK Middle School
 - Repaired MAJOR slope failure by re-building and improving drainage, re-filling area and stabilizing

Before

After

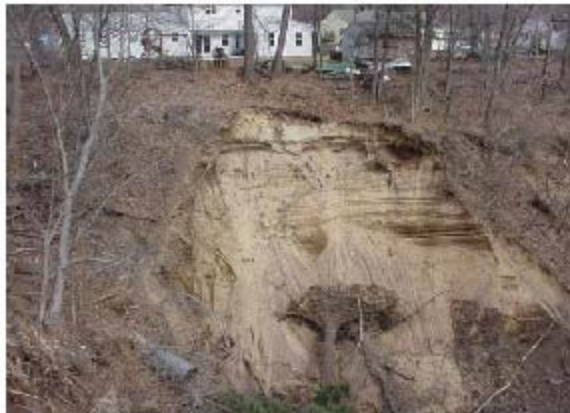
Sun Street Ravine

- Highly erodible soils along the side slopes
- Slope failures endangering private properties

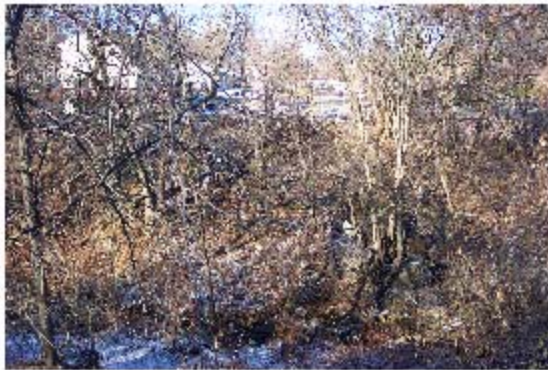
Chief Street Erosion

- Damaged Town drainage pipe
- Minor erosion around damaged pipe

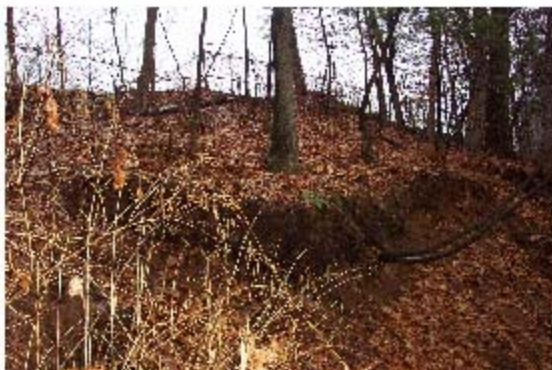
Erosion of Terry Brook at Nathan Hale School

- Brook eroding the side slope – moderate in severity
- School field starting to dip in one spot – several severe rain events could lead to loss of portion of field – similar to JFK, though less severe

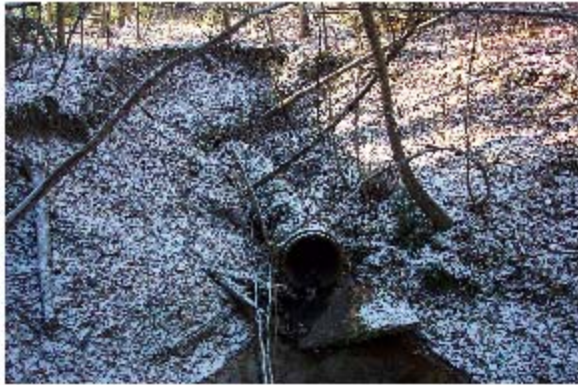
22 Shannon Drive Erosion

- 36" drainage pipe has disconnected and is causing erosion
- Large sink-hole also present

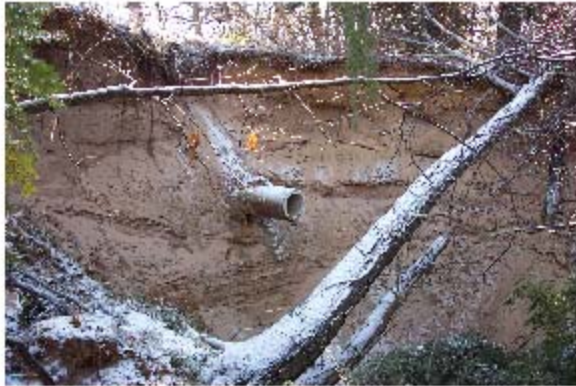
Transfer Station Detention Outlet - Town Owned

- Detention basin outlet pipe failed causing severe erosion in Terrace Escarpment Slope
- Fill material on site

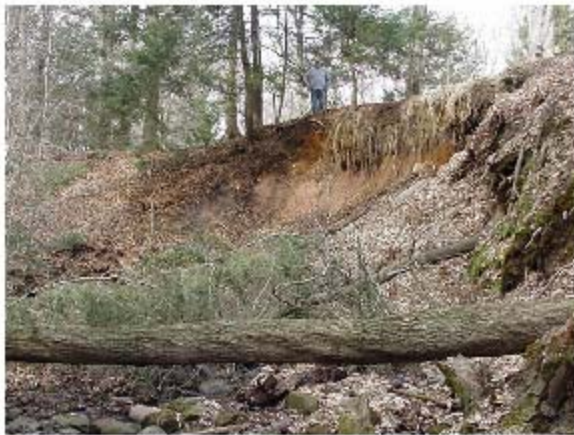
Gordon Lane Ravine

- Portion of State RT 190 drains into ravine
- Small well-armored outlet from Gordon Lane (Town owned) drains into ravine
- Private improvements and dumping have affected area
- Very erodible soils – both sides of ravine failing
- Homes on Gordon and Powder Ridge affected
- Easements on 14 +/- properties needed

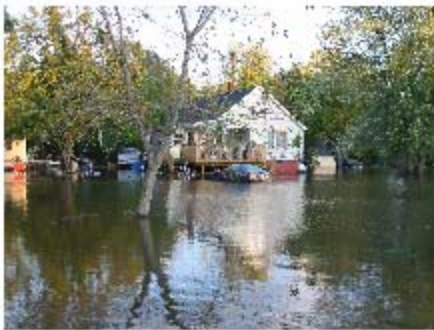
Lynch and O'Hear Flooding Issue

Problem involves the underpass at RT 5, which is undersized. In times of heavy rain, the underpass backs up water into this area and causes flooding. Partial blockage of culvert increases this problem.

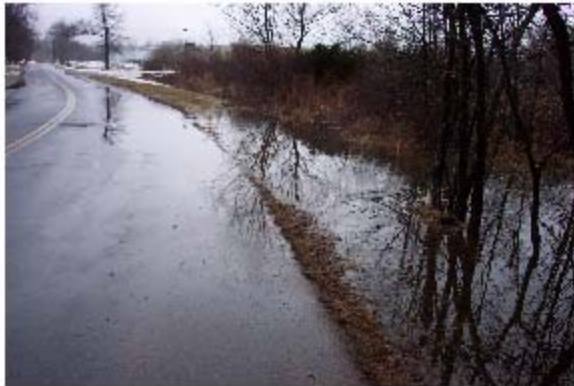
Post Road Curve - Flooding Issue

- Area overtops several times per year
- Problem is combination of an undersized pipe, level wetland area with slow drainage, and low road elevation.
- Solution involves replacing pipes with larger culverts and raising road
